NASA CR 72534

CdS SOLAR CELL DEVELOPMENT

CLEVITE CORPORATION

FINAL REPORT

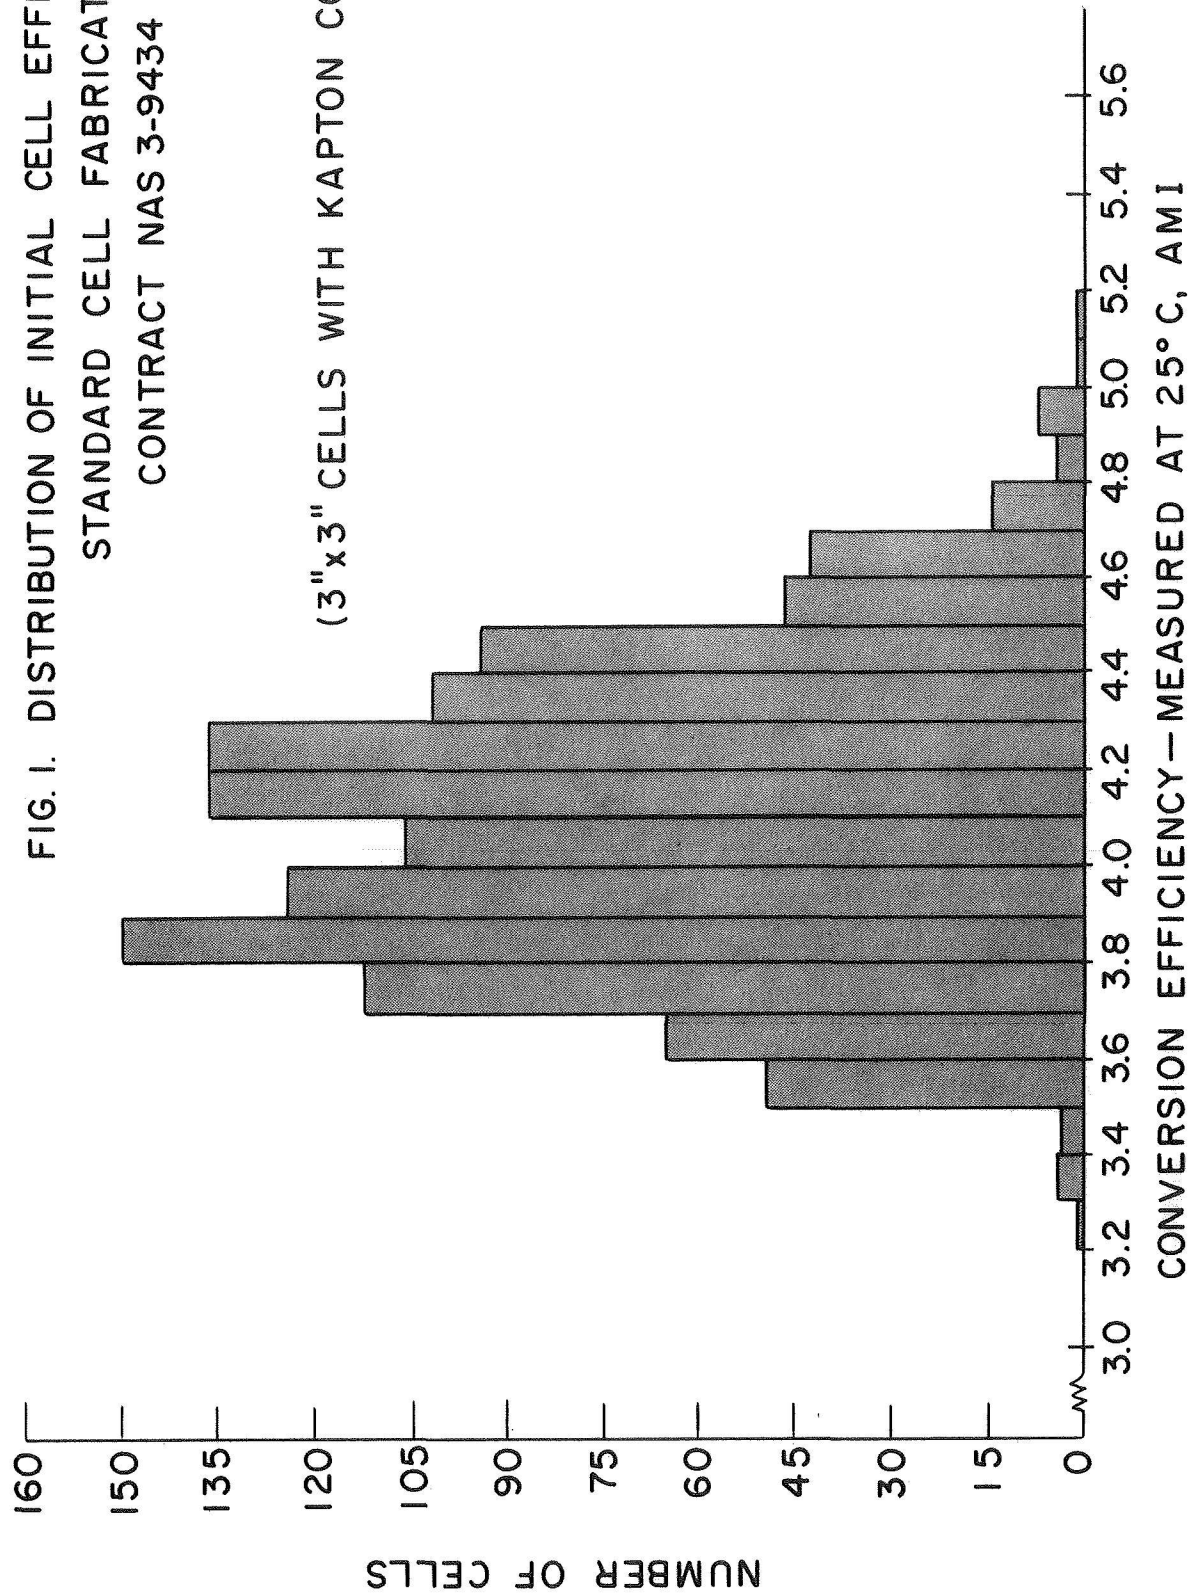
FIG. 1. DISTRIBUTION OF INITIAL CELL EFFICIENCIES
STANDARD CELL FABRICATION
CONTRACT NAS 3-9434

Over the 13 months of this report period, average cell output levels varied very little. Figure 1 is a histogram giving the distribution of air mass 1 conversion efficiencies measured at 25°C on standard process Kapton covered 3" x 3" size cells fabricated during the 13th through the 25th months of the Contract. Figure 2 is the experience with the open circuit voltage, Figure 3 for the short circuit current, Figure 4 for the voltage at the maximum power point and Figure 5 for the current at the maximum power point for the same cells measured under the same conditions.

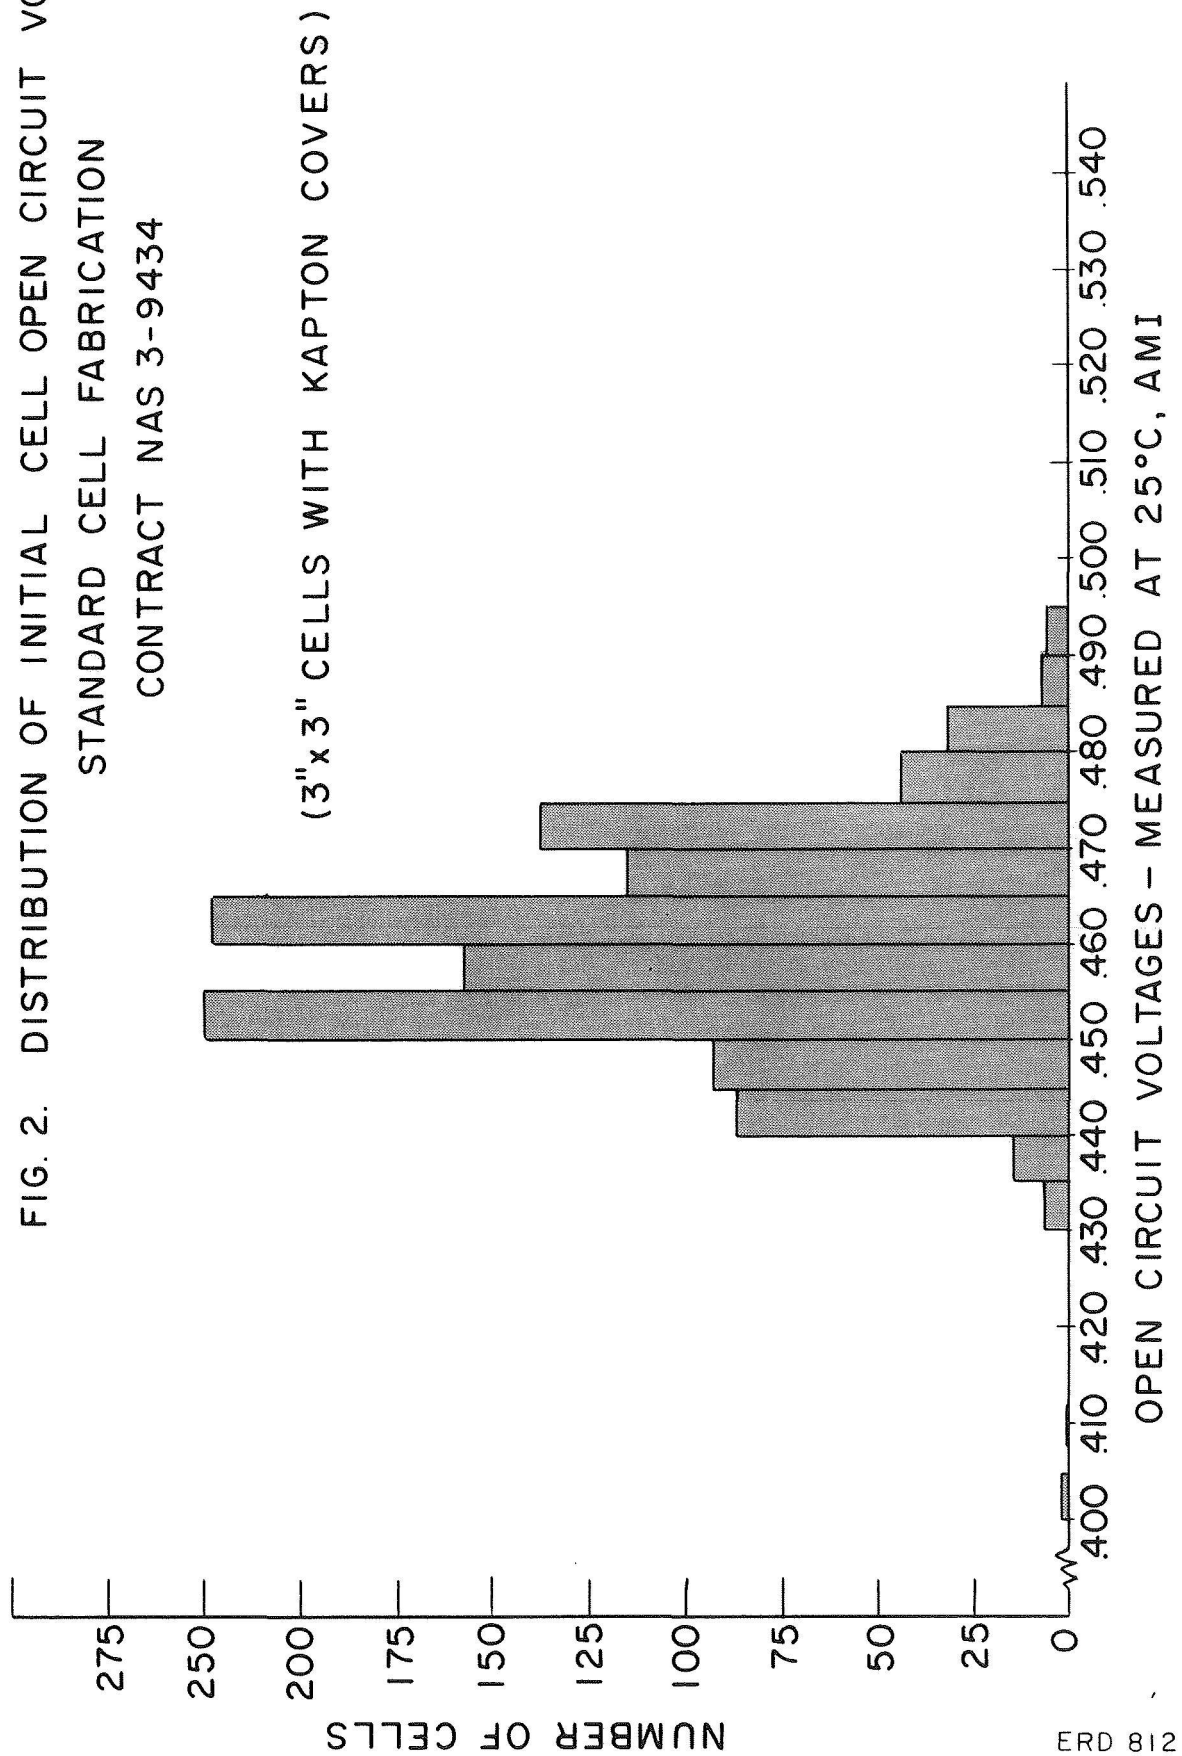
FIG. 2. DISTRIBUTION OF INITIAL CELL OPEN CIRCUIT VOLTAGES
 STANDARD CELL FABRICATION
 CONTRACT NAS 3-9434

There is obviously a lot of improvement that can still be made in the performance of these cells. The lack of Gaussian distribution patterns for the attributes in Figures 2 to 5 indicates that the process is not under control.

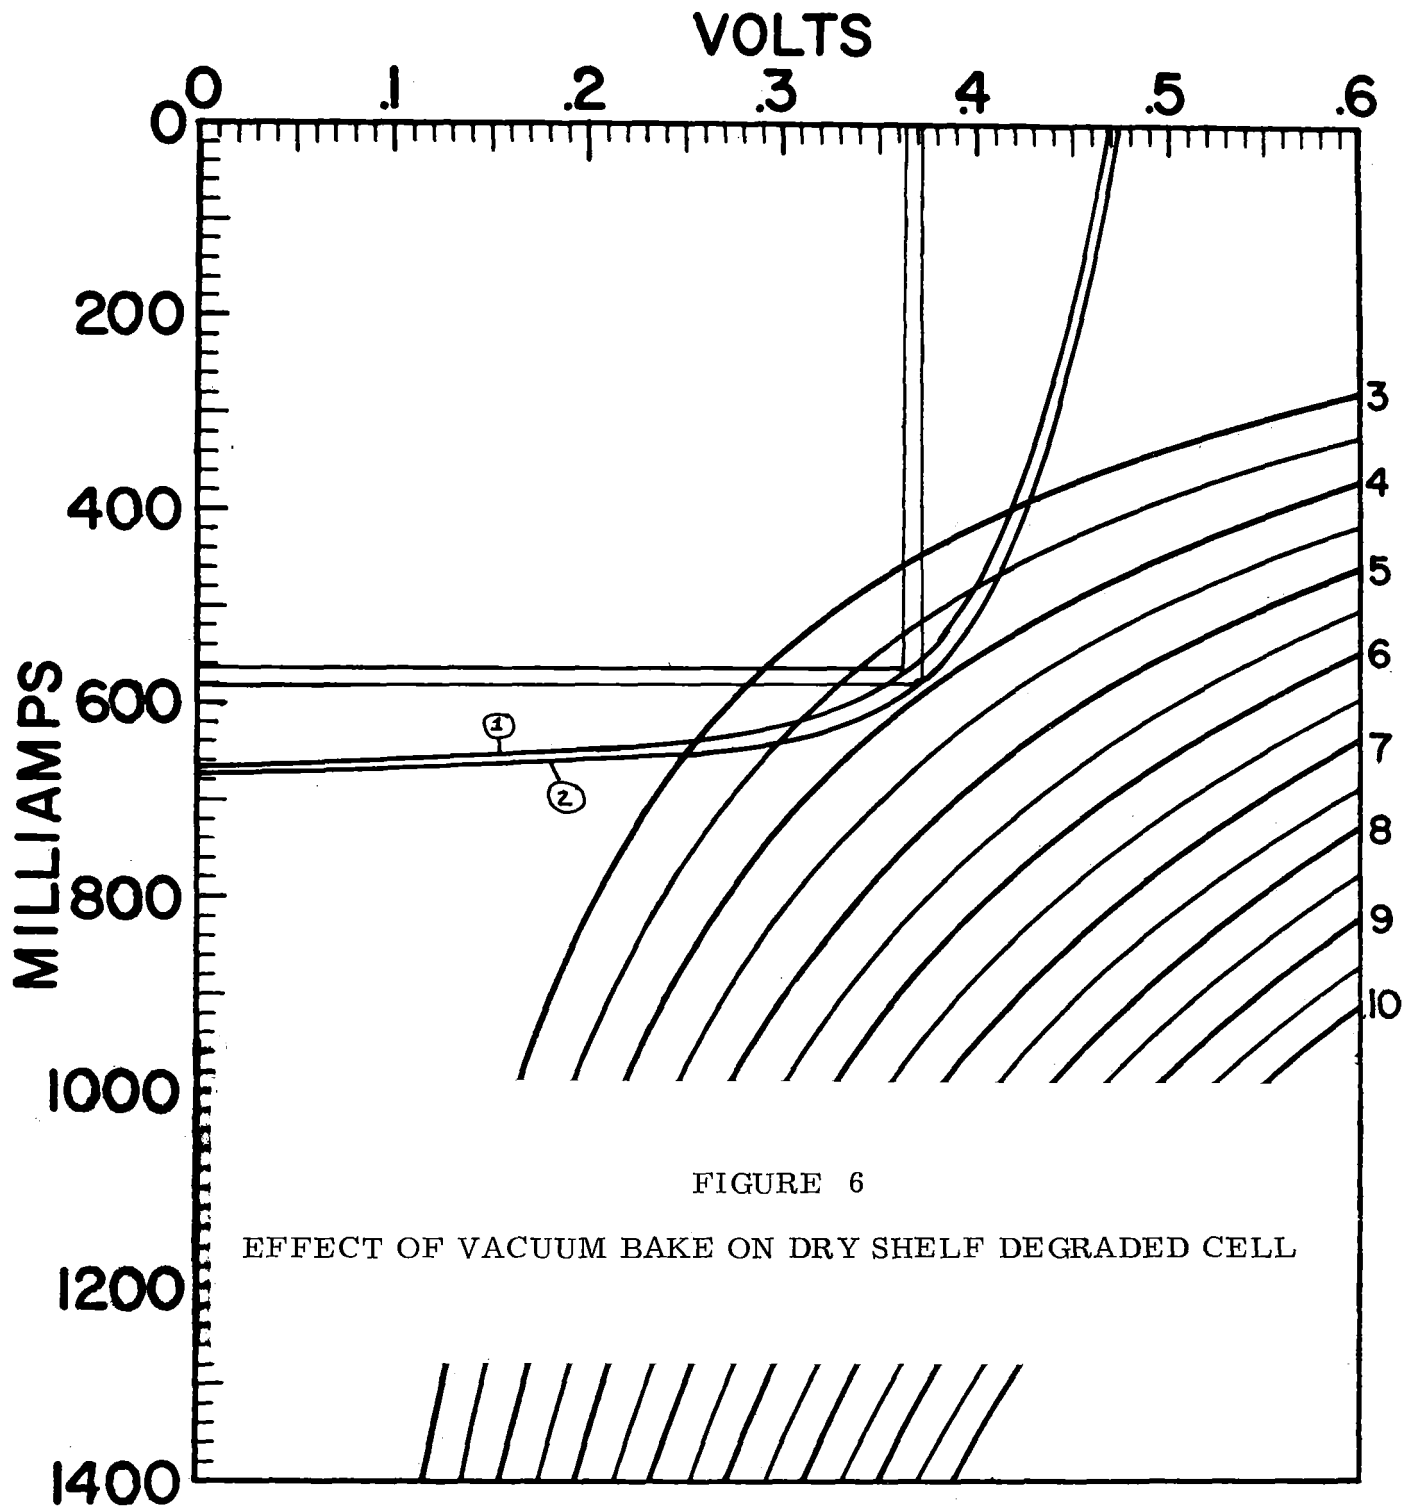
FIGURE 6

CELL No. N197 AK1
SHEET No. OF
AREA= 54.75 cm
AMI @ 25°C

EFFECT OF VACUUM BAKE ON DRY SHELF DEGRADED CELL

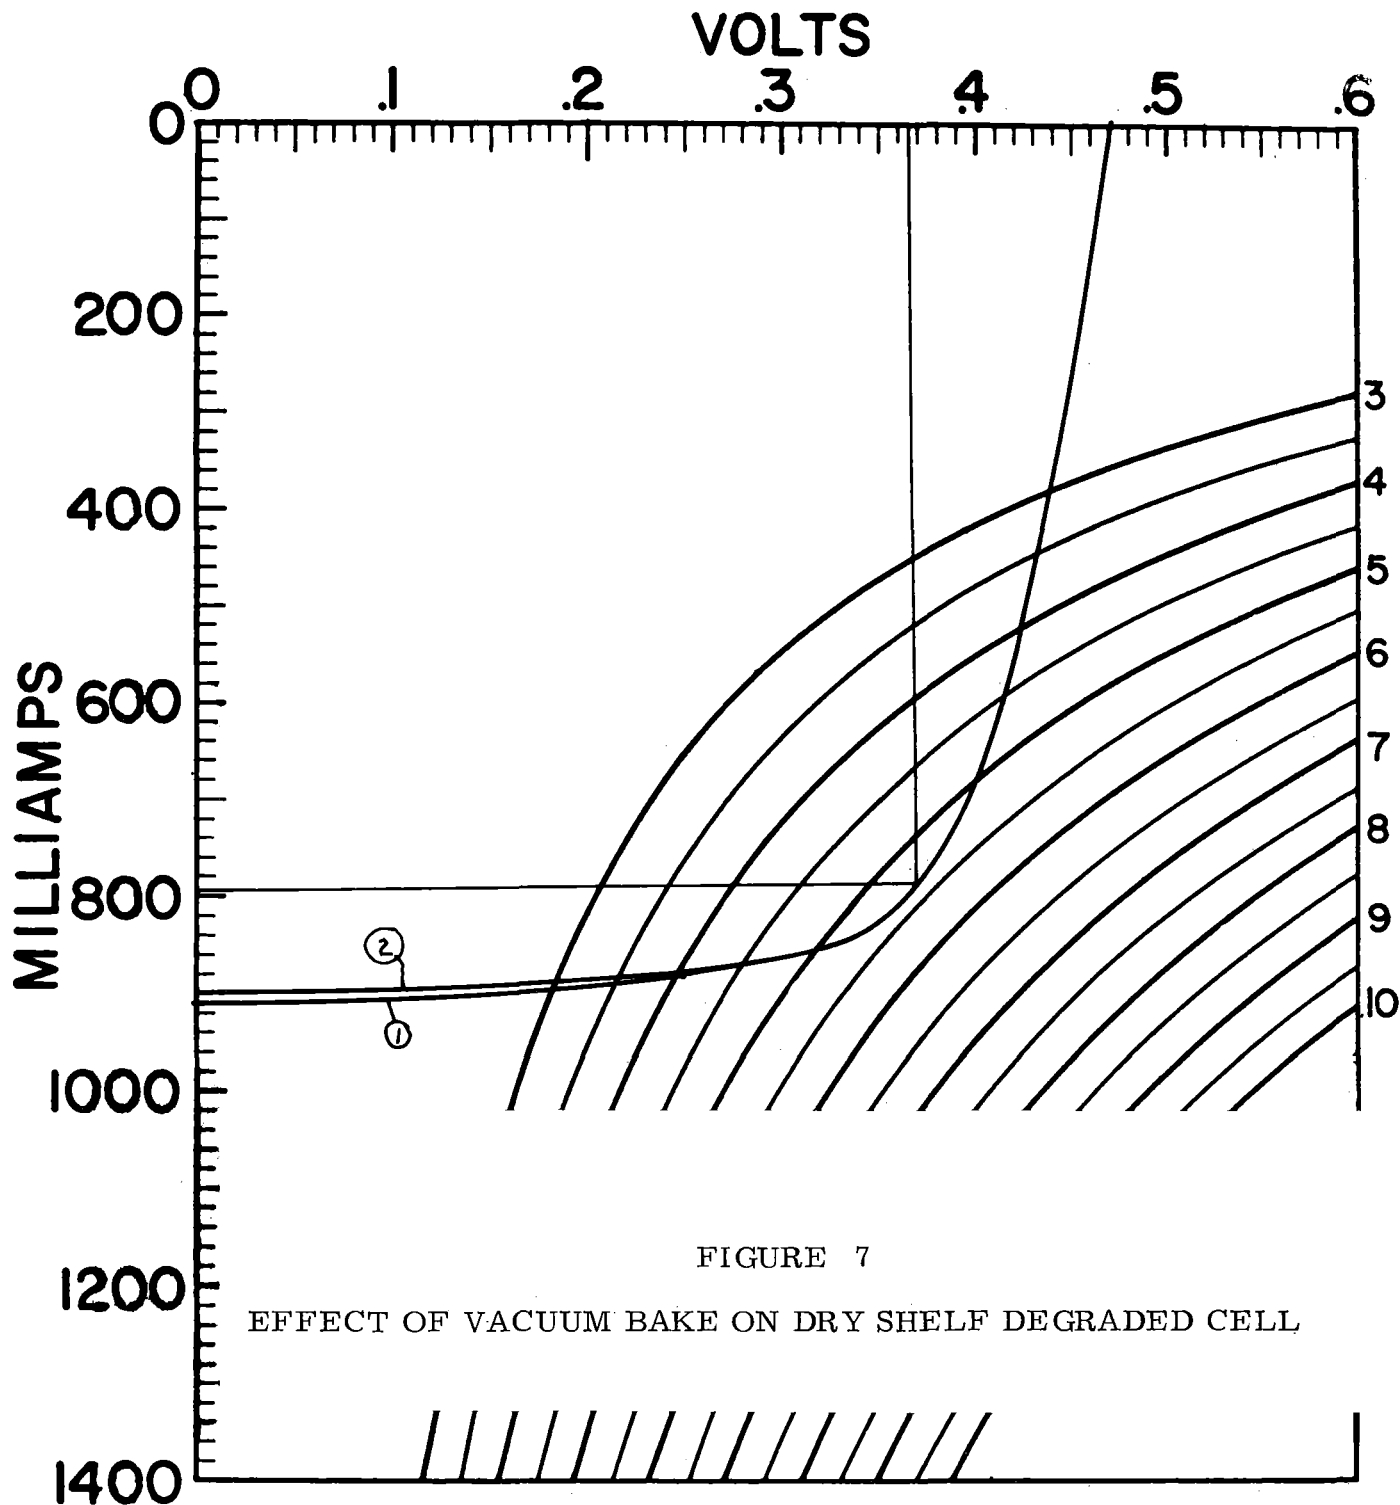
FIGURE 7

rate of 7.5% which is still much too high for dry shelf conditions. Heating this cell overnight in a vacuum oven made no change in the power output, as can be seen in Figure 7, though the fill factor did improve slightly at the expense of the short circuit current.

EFFECT OF VACUUM BAKE ON DRY SHELF DEGRADED CELL

A careful analysis of the I-V curves of the cells listed in Tables II, III and IV which showed some loss of output on dry shelf storage, discloses no common pattern of behavior. Most of the cells that degraded lost short circuit current. Some lost open circuit voltage as well. Some lost in fill factor. While it has not been possible to analyze in detail all of the cells which showed a loss of output on this test and to ascribe a definite cause in each case, a cursory examination of the cells and the data sheets leads to the conclusion that a number of different failure mechanisms must have been operating for these cells. For instance, Cell N197AK1 which was made in May 1968 degraded in 28 weeks from 4.0 to 3.7% efficiency or at an annual rate of 14% of its initial value. This cell was heated overnight in a 135°C vacuum oven and recovered to 3.9% efficiency. The sequence is shown in Figure 6. This is what would be expected if the degradation had been caused by moisture. Just how moisture could have been picked up by this cell is a mystery. On the other hand, Cell N86C5 degraded from 5.9 to 5.3% in 16 months. This is an annual degradation

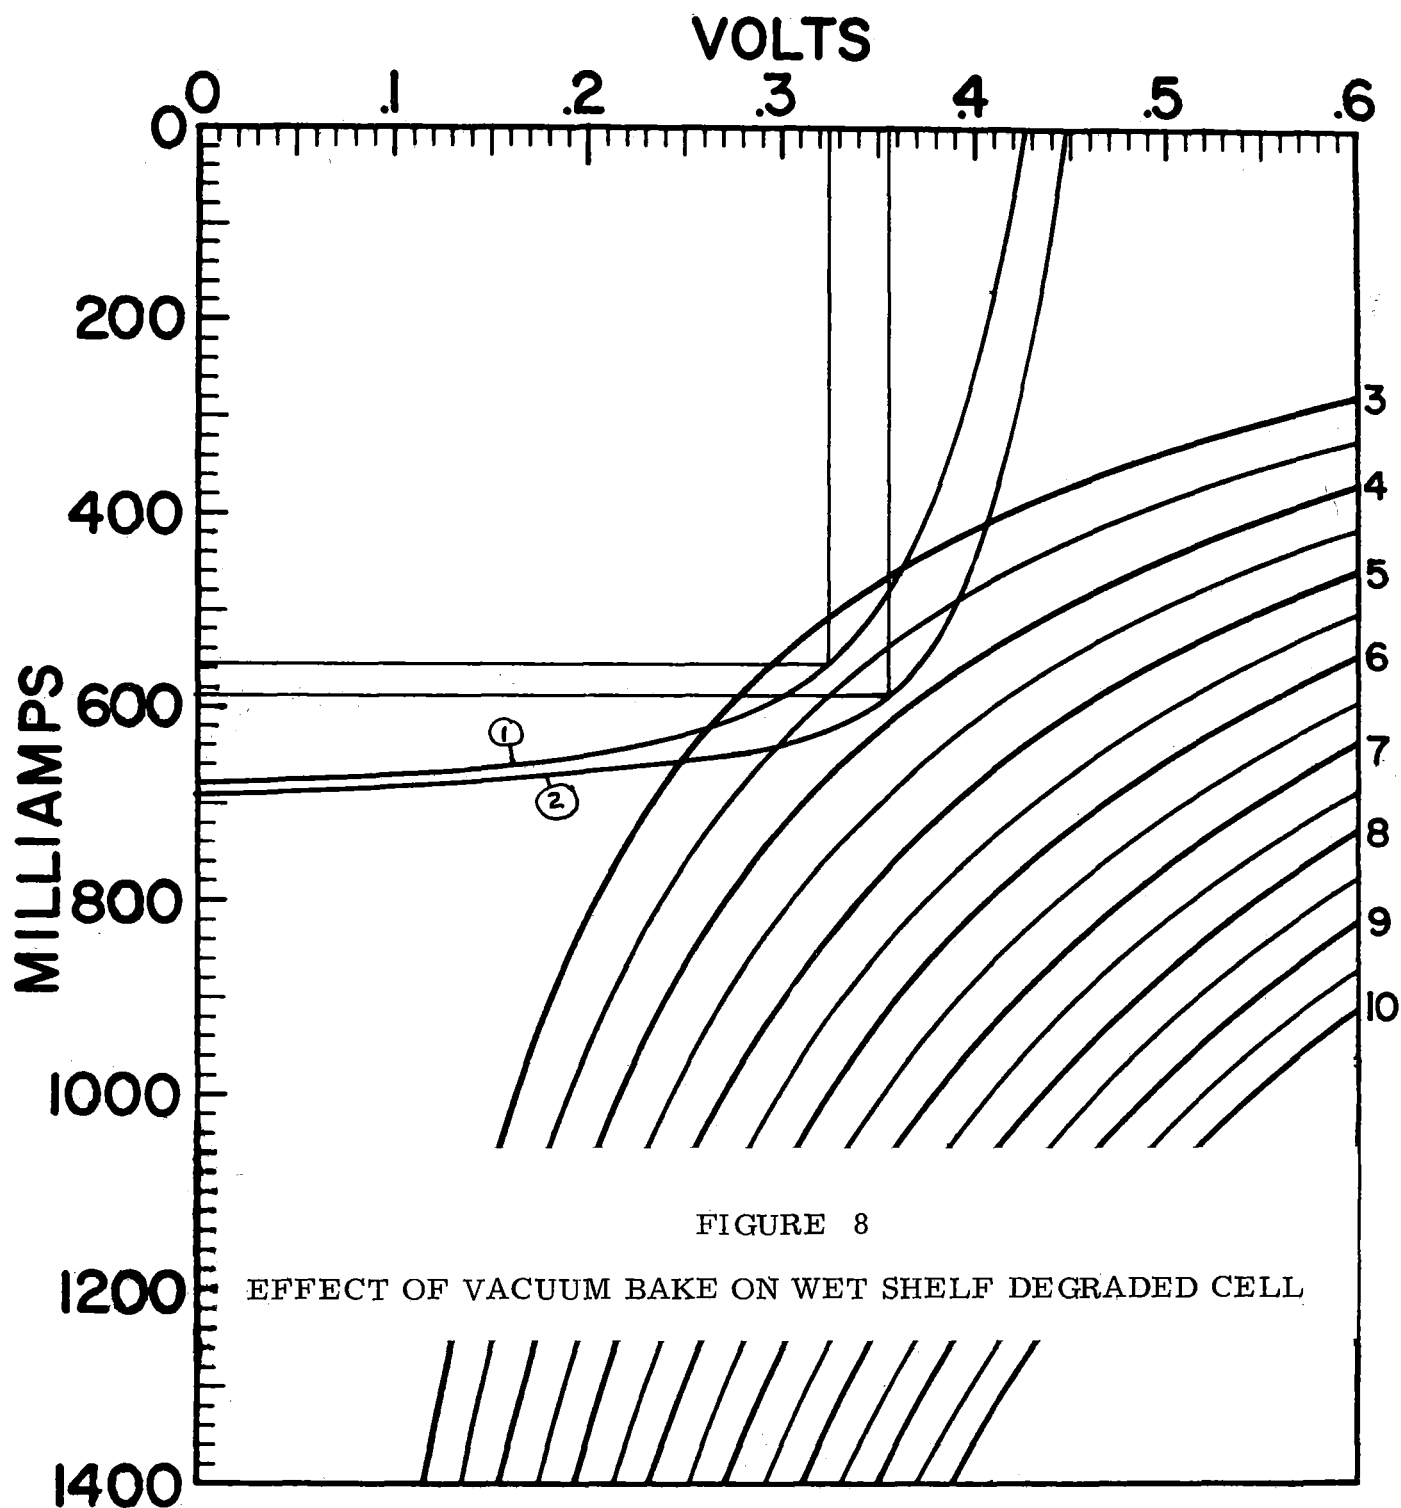
FIGURE 8

Two cells that had shown appreciable degrees of output loss on wet shelf storage were selected and were baked overnight in a vacuum oven at 135°C and then retested. One of these was Cell D454A which had degraded after 24 months of 80% humidity storage from 5.2 to 3.4% efficiency, and then to 3.3% by the time of the bake out. After the bake out the cell output rose to 3.8%. The before and after I-V curves are presented in Figure 8. It is seen that OCV, SCC and fill all improved with perhaps the OCV showing the most improvement. If the interpretation is correct then, this cell degraded from 5.2% to 3.8% by causes other than the moisture, and from 3.8% to 3.3% by the moisture. Thus the annual rate of moisture degradation was only 4.8%.

EFFECT OF VACUUM BAKE ON WET SHELF DEGRADED CELL

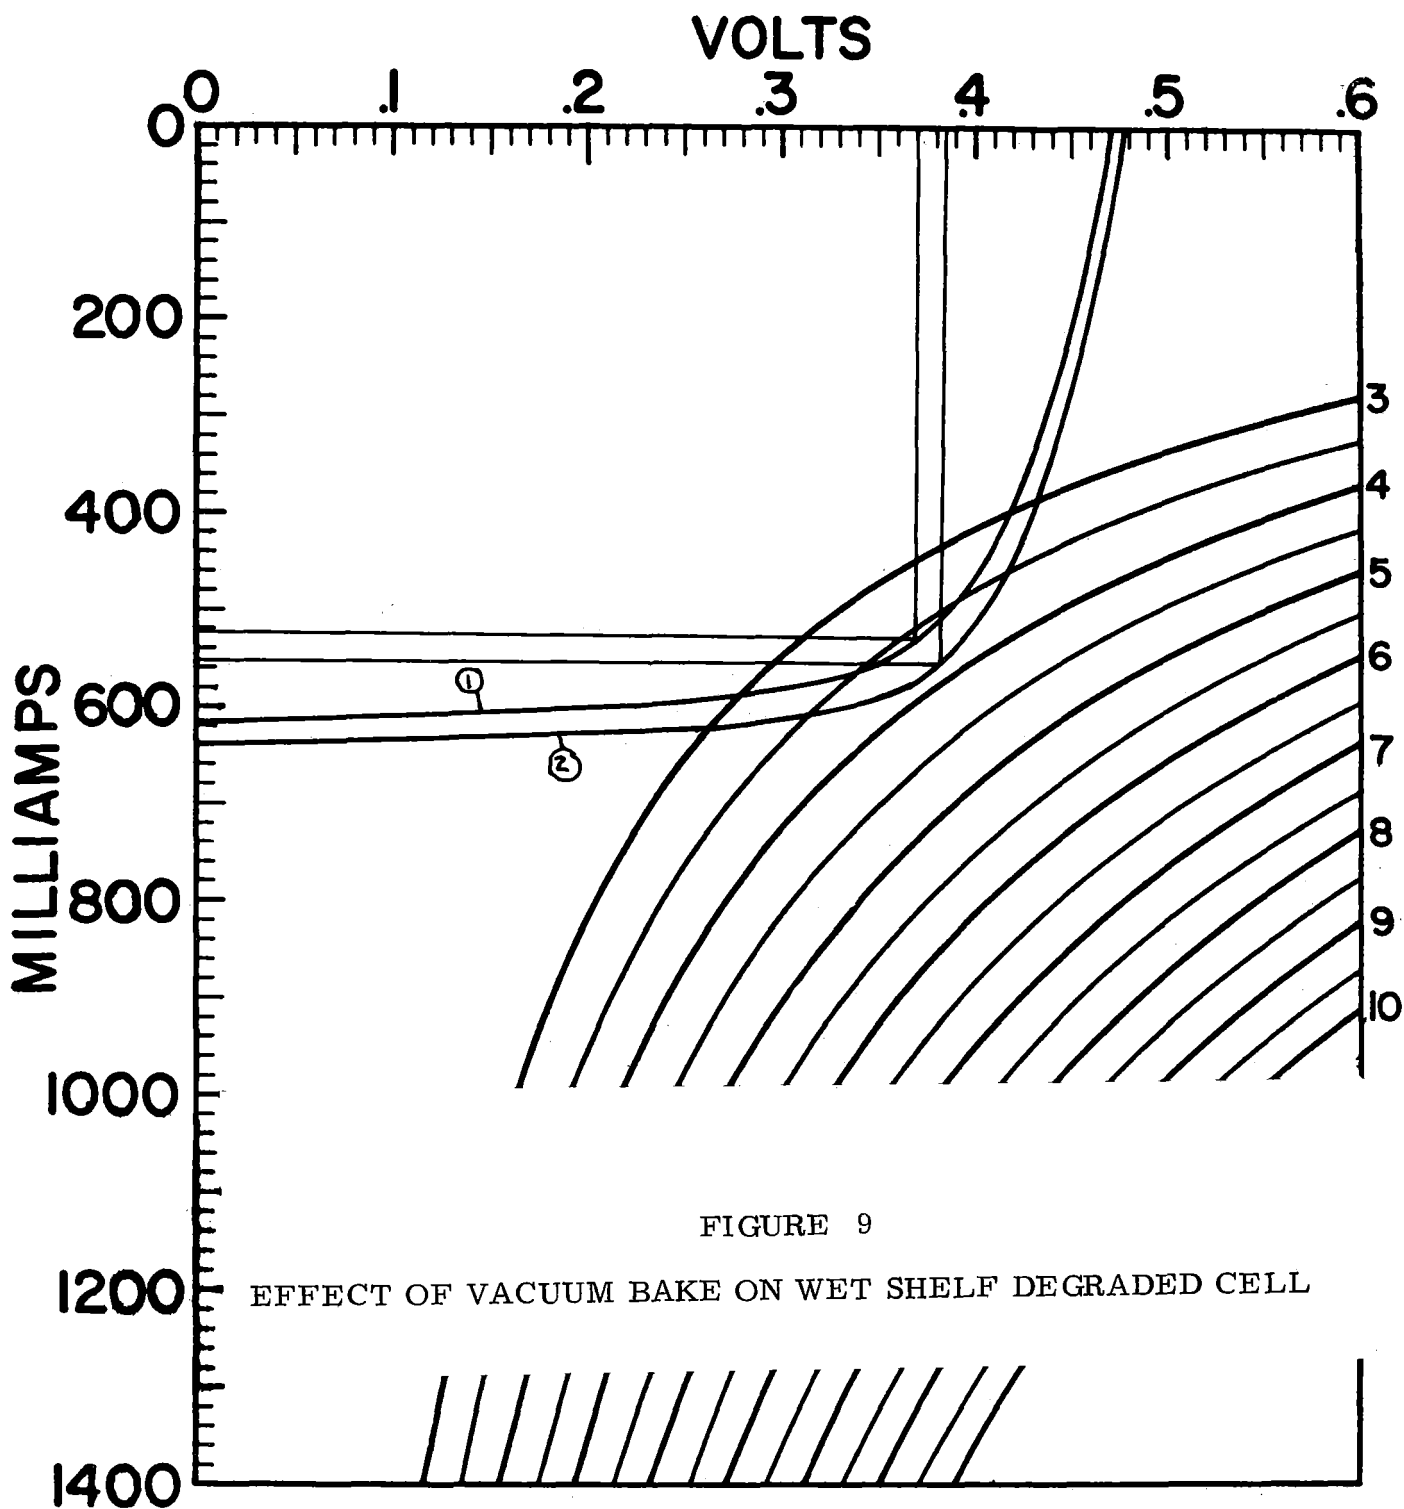
FIGURE 9

The other was Cell N185CK8 which had dropped from 4.0% to 3.6% efficiency in 36 weeks of wet shelf storage, and then to 3.5% by the time of the bake out. After the bake out the cell's efficiency was 3.9%, as shown in Figure 9. Again, OCV and SCC and fill were all affected. The annual rate of moisture degradation for this cell on the same basis would be just over 10%.

EFFECT OF VACUUM BAKE ON WET SHELF DEGRADED CELL

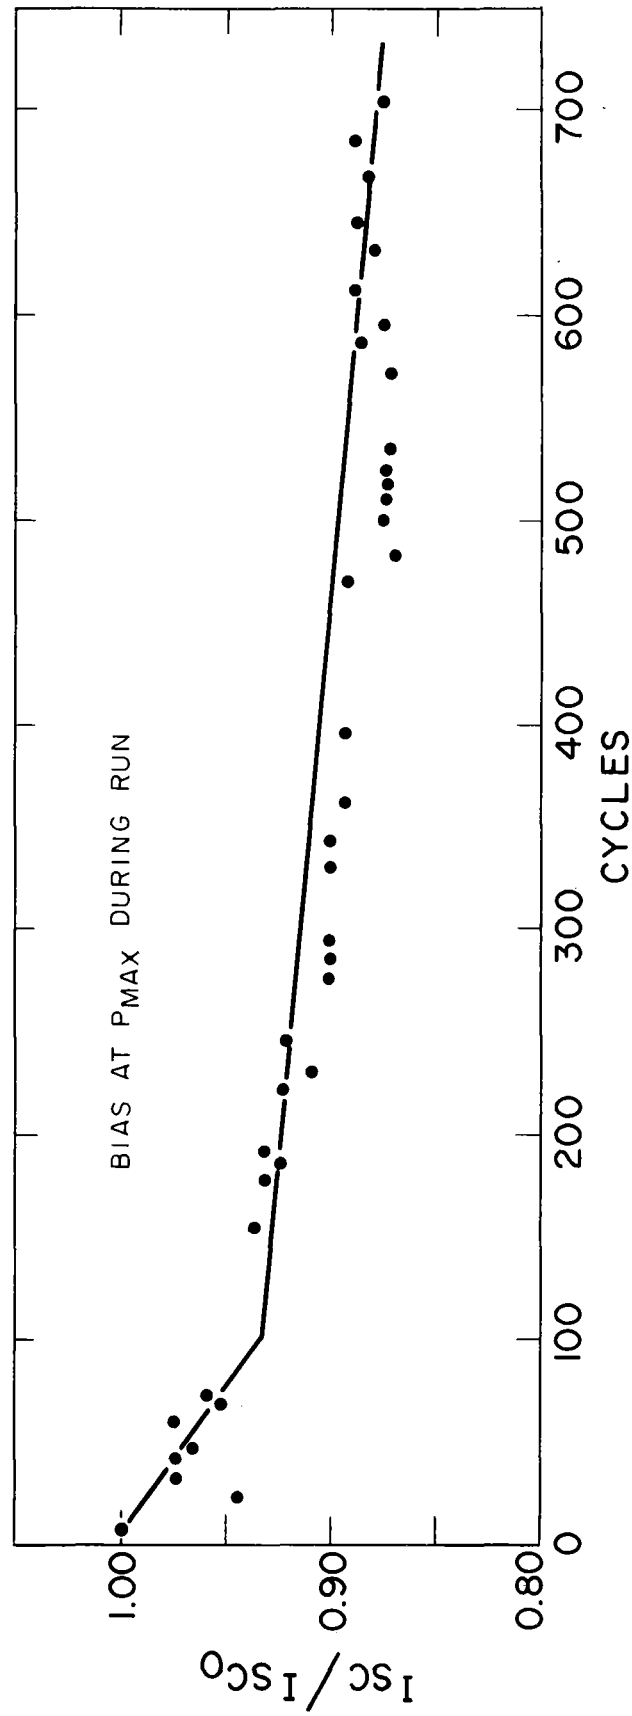
Preliminary data only have been received from Lincoln Laboratory and this is presented in Figure 10. There was a fairly rapid loss of short circuit current over the first 100 cycles and then a much slower loss thereafter. There were 3 cells on this test. Two of the cells showed no loss in open circuit voltage over 700 cycles. These data are comparable with earlier Lewis Research Center and Boeing thermal cycling tests.

FIG. 10. SHORT CIRCUIT CURRENT DEGRADATION OF LINCOLN LABORATORY THERMALLY CYCLED CELLS.

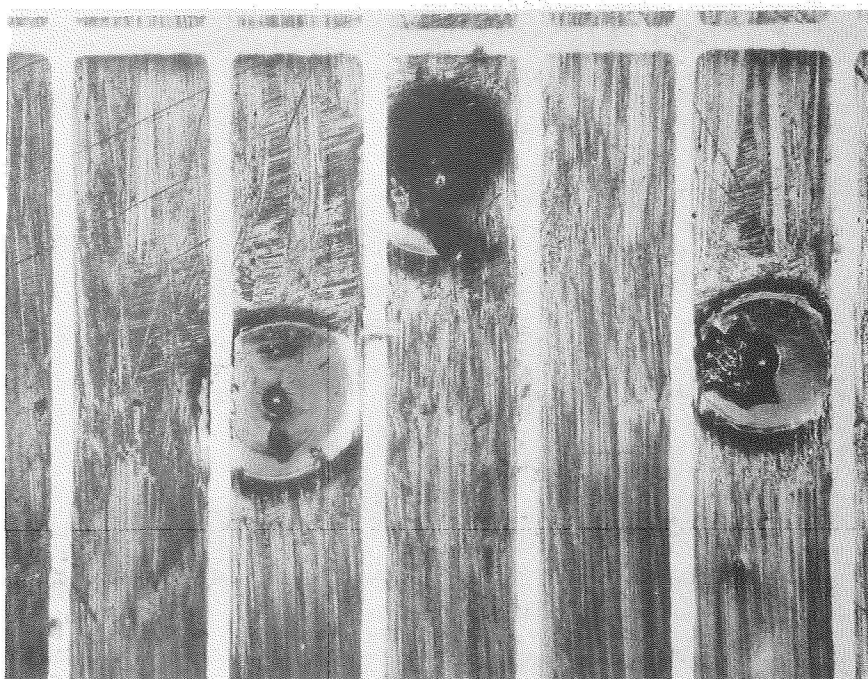
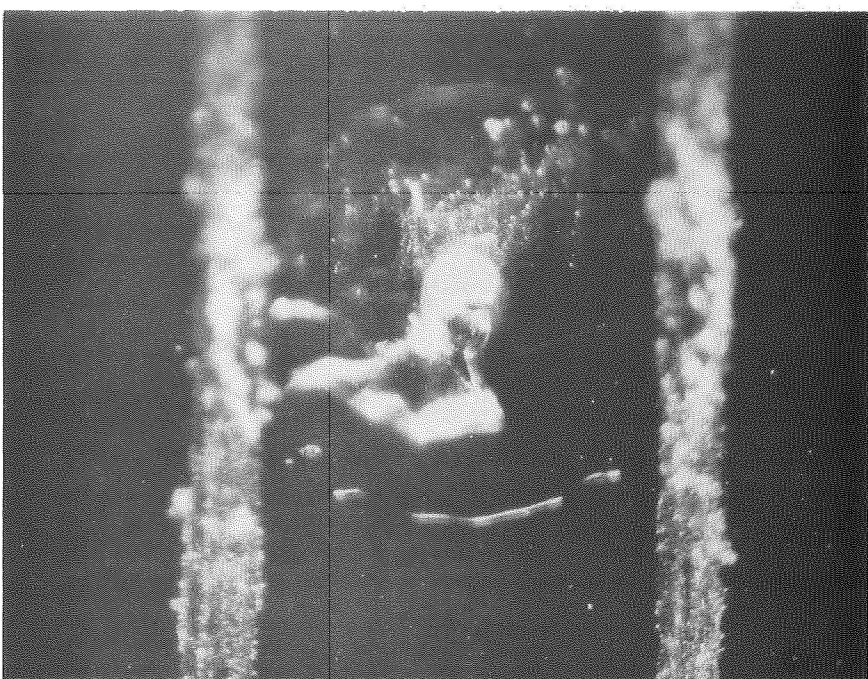
FIGURE 11

The nodules caused a visible lifting of the cover plastic, and in a few cases of a grid wire. Figure 11 is a photo of the nodules on a part of one cell at two different magnifications. The nodule is the small central portion of the larger circular areas. The light circular region is where the nodule has pushed up the cover plastic causing a void in the package. A nodule grown on a gridded cell that had no cover plastic is shown in Figure 12. Analysis of one of the nodules which was lifted from one of the cells disclosed it to be elemental copper.

Copper Nodules found on the copper sulfide barrier
of a standard CdS Solar Cell after Constant Illumination

It is known that Cu_2S has a very strong ionic conductivity at high temperatures. It is presumed that there is some ionic conductivity at room temperature. Copper ions would move in an electric field if that field were above a certain threshold value. The electric field in the Cu_2S barrier region of a cell on open circuit in the light would be such as to move copper ions toward any region that might be even partially shorted to the negative substrate. In the loaded condition the electric field in the cells would be less and the effect would be less and less as the current increased.

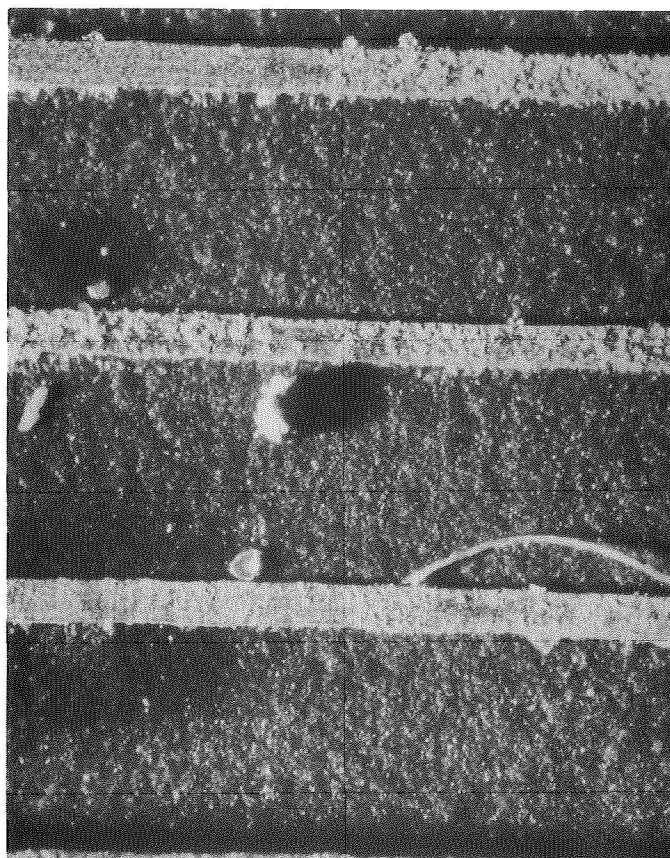
65X

Cell No. H742B9

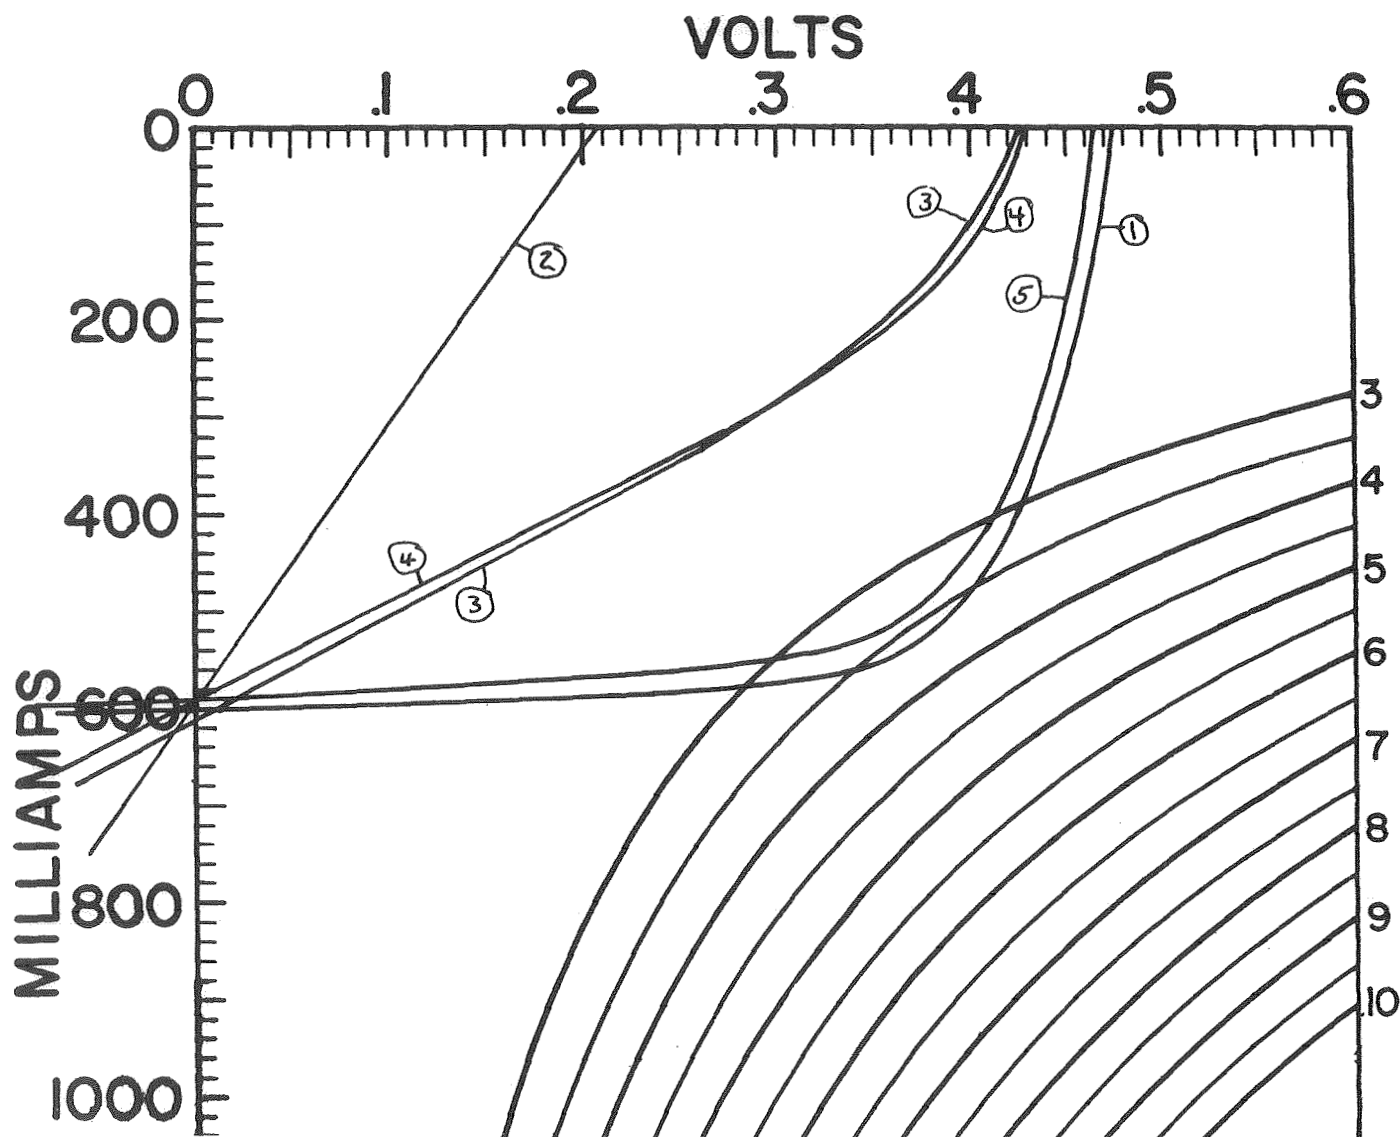
FIGURE 13

EFFECTS OF DRIVING CELL FROM EXTERNAL VOLTAGE SOURCE

It is proposed that the mechanism for the degradation of these cells was the same as for the light degraded cells - even though no copper nodules were observed on these particular cells - and that copper was actually plated out at short circuiting points on these cells. The reverse biasing would effectively back plate the copper and hence remove the degradation.

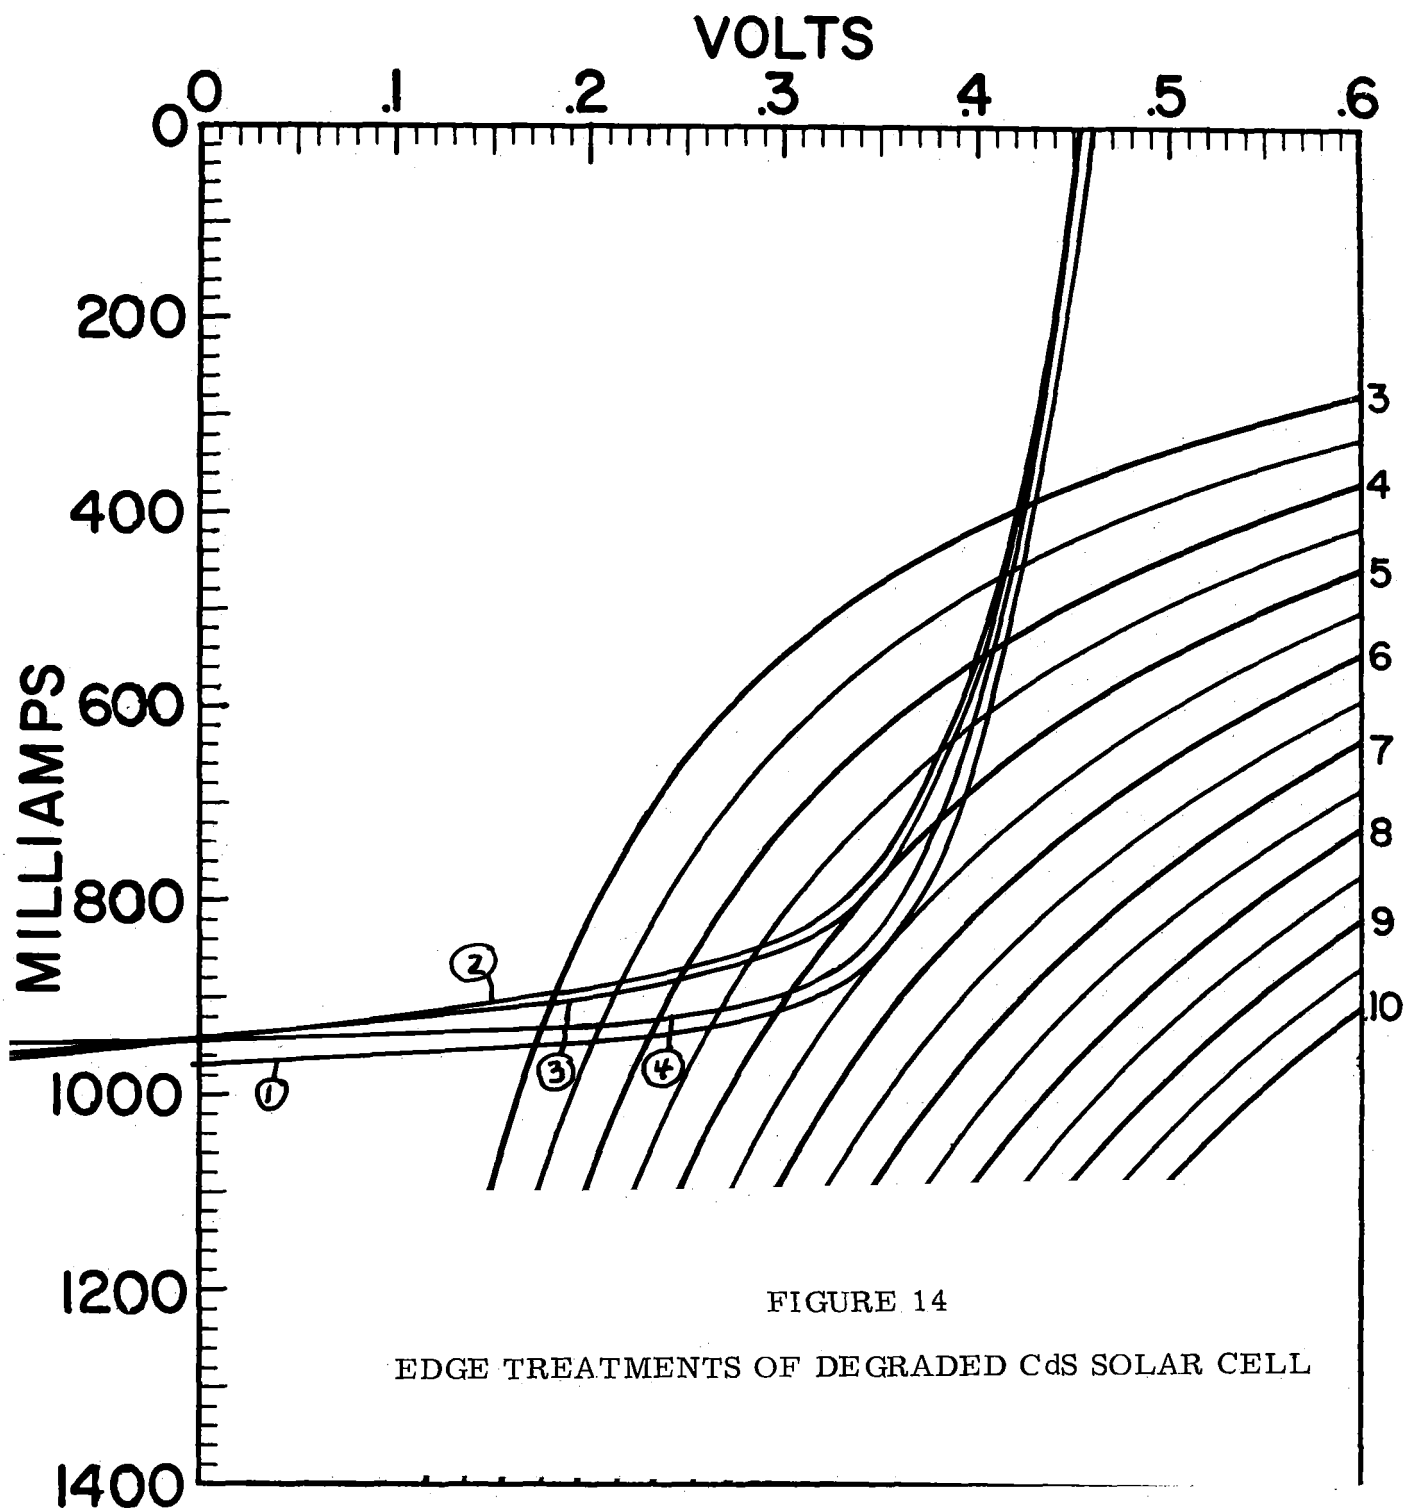
FIGURE 14

EDGE TREATMENTS OF DEGRADED CdS SOLAR CELL

Two relatively straightforward methods of protecting the cut edges of single cells have been worked out. One of these is to simply cement a narrow "U" - shaped strip of Kapton plastic cover over each edge as illustrated in Figure 15a. The other is to cut the cell to width prior to cover plastic lamination, make the cover plastic slightly wider than normal and fold it over each edge in the lamination step as illustrated in Figure 15b.

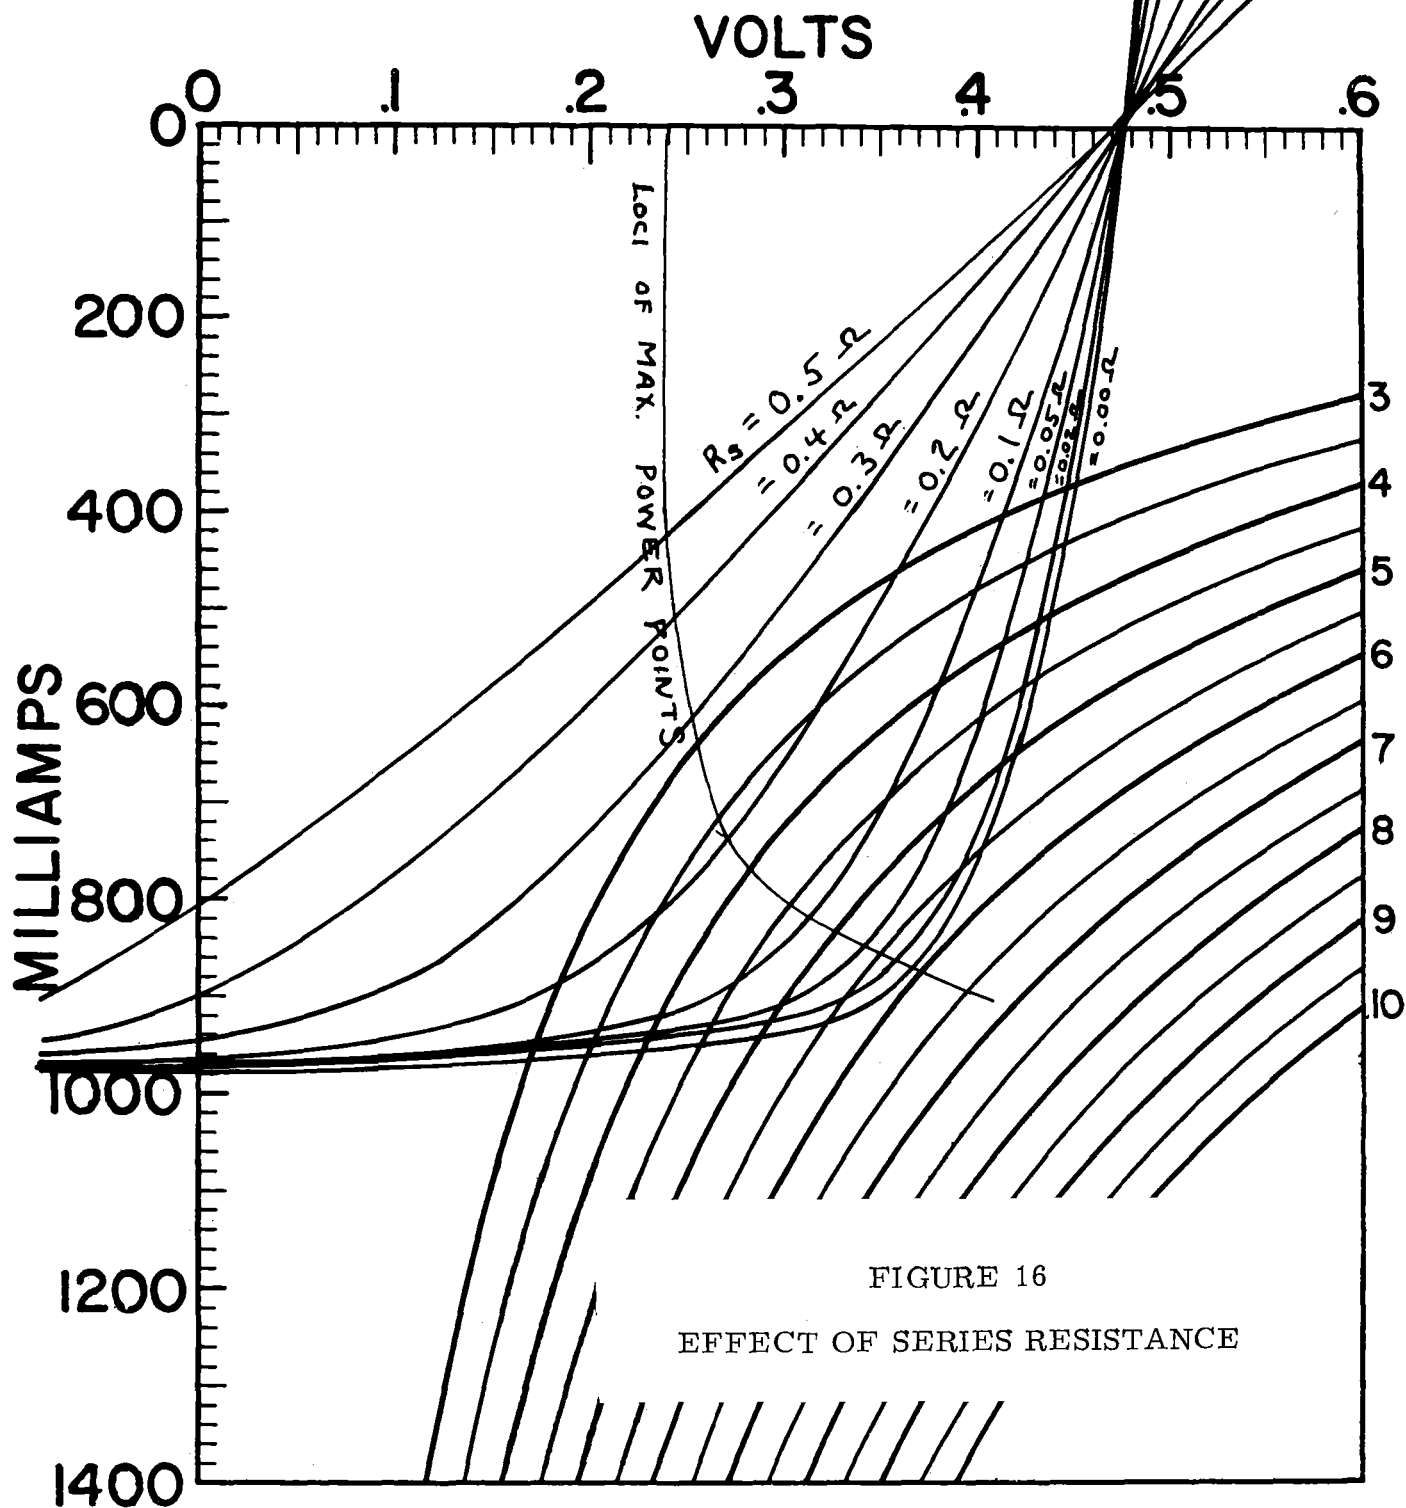
FIGURE 16
EFFECT OF SERIES RESISTANCE
